FIRE RISK ASSESSMENT

Block: Crocodile Court Block Y (*09-*15)
209 ALMA STREET
NEWTOWN
B19 2RL

Date of Assessment: 03/04/2024

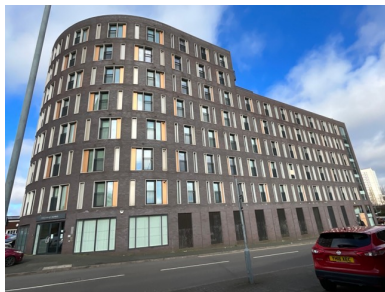
<p>Fire Safety Management</p>	<p>Action/Findings: 1 FIRE LOSS EXPERIENCE</p> <p>Is there any known Fire History?</p> <p>: There was no visible history of fires at the time of inspection in 2024 and no incidents have been reported by the Concierge or recorded on the fire digital record, C365.</p>	<p>Medium</p>

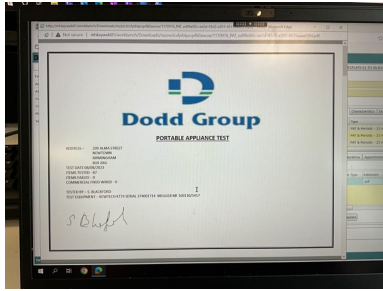
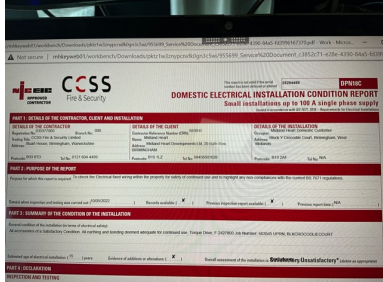
<p>Fire Safety Management</p>	<p>Action/Findings: 2 ELECTRICAL SOURCES OF IGNITION.</p> <p>Are reasonable measures taken to prevent electrical Fires. YES Are fixed installations periodically inspected and tested? YES Is portable appliance testing carried out? YES Is there suitable control over the use of personal electrical appliances? YES Is there suitable limitation of trailing leads and adapters? YES Are there appropriately sited facilities for electrical isolation of any photovoltaic (PV) cells, with appropriate signage, to assist the fire and rescue service? There are no PV cells provided on this block, the adjoins Townhouse, do have solar panels installed on their roof but would not effect this premises.</p> <p>: This risk assessment covers the communal area and offices on the Ground floor, there are no portable appliances in the communal areas, however, the electrical items in the office all are PAT tested every 2 years.</p> <p>The last portable appliance testing was carried out on the 08/08/23.</p> <p>Periodic inspection and testing of the fixed electrical installations EICR are carried out as part of a planned, preventive maintenance programme. The date of the last test was 10/05/22.</p> <p>The use of electrical extension cables are managed well within the office area and appear to be suitable for their required use.</p> <p>All Plugs and sockets appeared to be in good condition and are solely for the use to carry out house maintenance services.</p>	<p>Medium</p>

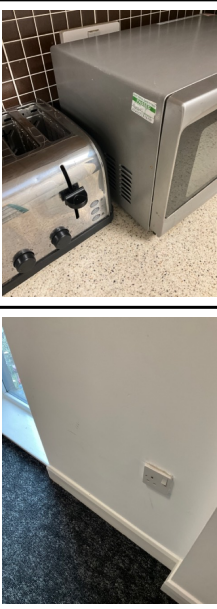
<p>Fire Safety Management</p>	<p>Action/Findings: 2 ELECTRICAL SOURCES OF IGNITION.</p> <p>Are reasonable measures taken to prevent electrical Fires. YES Are fixed installations periodically inspected and tested? YES Is portable appliance testing carried out? YES Is there suitable control over the use of personal electrical appliances? YES Is there suitable limitation of trailing leads and adapters? YES Are there appropriately sited facilities for electrical isolation of any photovoltaic (PV) cells, with appropriate signage, to assist the fire and rescue service? There are no PV cells provided on this block, the adjoins Townhouse, do have solar panels installed on their roof but would not effect this premises.</p> <p>: This risk assessment covers the communal area and offices on the Ground floor, there are no portable appliances in the communal areas, however, the electrical items in the office all are PAT tested every 2 years.</p>	<p>Medium</p>

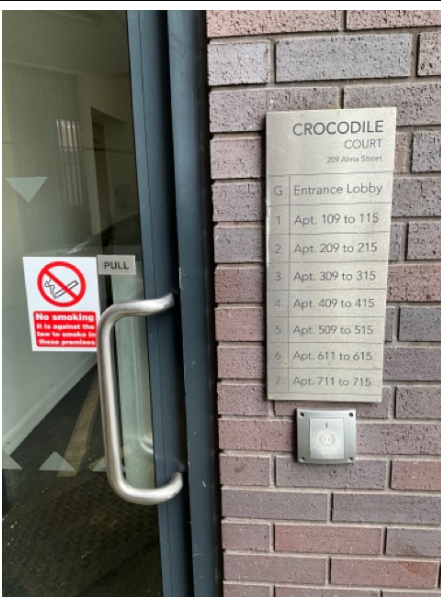
<p>Fire Safety Management</p>	<p>Action/Findings: 3 SMOKING</p> <p>Are reasonable measures taken to prevent fires from Smoking. YES Are "No smoking" signs provided in the common areas? YES Is smoking prohibited in appropriate areas? YES Are there suitable arrangements for those who wish to smoke? YES Did the smoking policy appear to be observed at time of inspection? YES</p> <p>: Smoking is prohibited in the communal areas. Appropriate signage is in place in accordance with the requirements of The Smoke-free (Premises and Enforcement) Regulations 2006. These regulations do not apply to individual flats, where it is foreseeable that some occupants will smoke. This policy appeared to be observed at time of inspection.</p> <p>A smoking area is provided in the courtyard with a smoking disposal receptacle units fixed to the wall. Further signage is provided at the rear entrance to the property.</p>	<p>Medium</p>

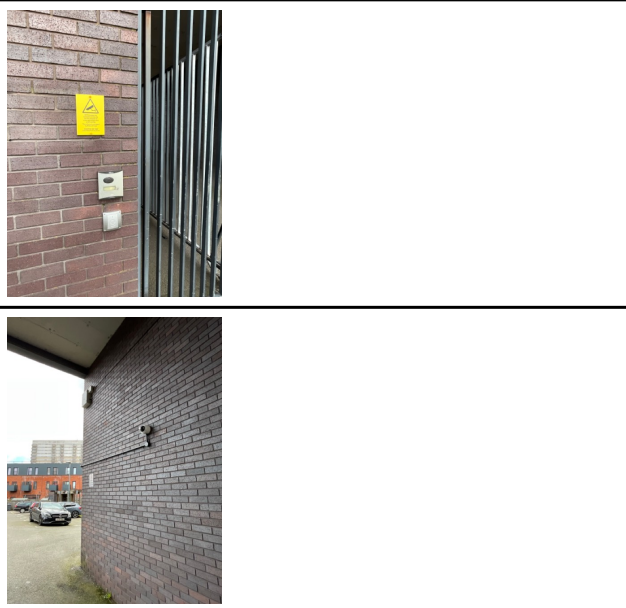
<p>Fire Safety Management</p>	<p>Action/Findings: 4 ARSON</p> <p>Does basic security against arson by outsiders appear reasonable? YES</p> <p>Is there an absence of unnecessary fire load in close proximity to the premises or available for ignition by outsiders? YES</p> <p>: Precautions against arson appear to be reasonable as these Blocks have a Concierge from 07:00hrs until 22:00hrs which monitor and address any anti social behaviour, additionally the Block has:</p> <ul style="list-style-type: none"> # CCTV cameras in operation. # The main entrance doors to the premises are fitted with secure door entry systems. # The main entrance door to the premises was locked at the time of inspection which is monitored by the concierge service. # Refuse bins are located in a secure external bin store. # The building is well lit. # Visiting Staff wear ID badges. # Electricity/Gas meter/cupboard Doors were all locked. # Unnecessary fire loading is well managed and discouraged in 	<p>Medium</p>

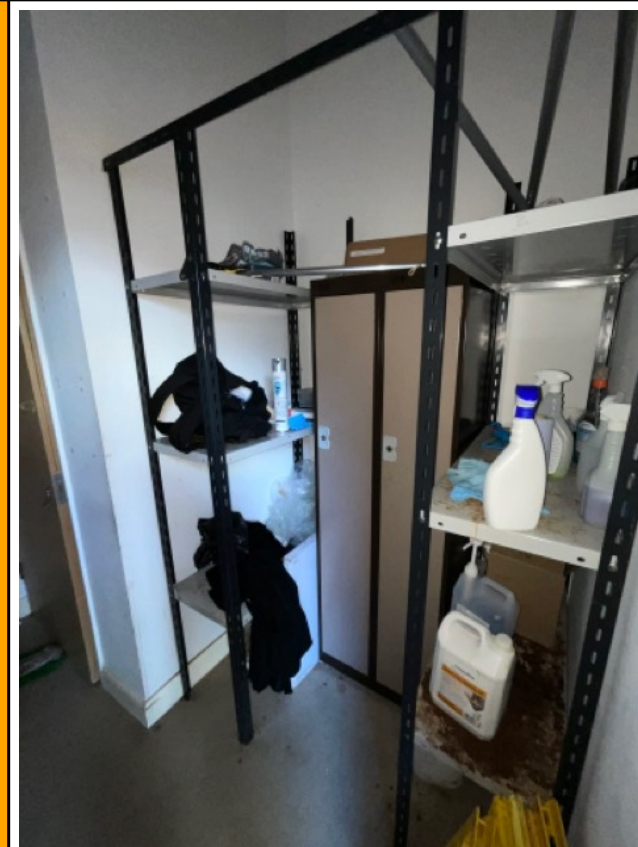
All stored items were within designated rooms, managed well and did not present a significant risk. There were no hazardous materials noted.

All plant rooms were generally free from combustible storage or controlled, which is best practice.

All escape routes were clear at the time of the assessment. The standard of housekeeping on site was exemplary again in 2024.

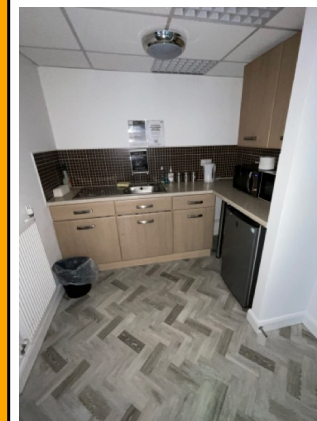
: Each flat is provided with its own kitchen. There are two small designated kitchenettes in the office area of the ground floor building for staff use only. These do not contain anything other than small electrical domestic appliances, (no cooking facilities, only microwave for food warming) and therefore form part of the normal electrical risk.
Detectors are located in these area which are linked to the Communal Fire Alarm.

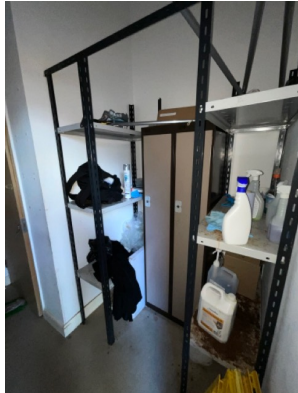
<p>Fire Safety Management</p>	<p>Action/Findings: 11 DANGEROUS SUBSTANCES & OTHER SIGNIFICANT FIRE HAZARDS THAT WARRANT CONSIDERATION.</p> <p>Are the general fire precautions adequate to address the hazards associated with dangerous substances used or stored within the premises? YES</p> <p>For the purpose of this risk assessment and the Fire Safety Order, dangerous substances are primarily explosive, highly flammable or flammable substances and oxidizing agents. Small quantities with negligible impact on the appropriate fire precautions need not be taken into account</p> <p>: This risk assessment only considers the impact of the use or storage of dangerous substances to the extent necessary to determine the adequacy of the general fire precautions required under the Order to ensure the safety of relevant persons in the event of fire. However, there were no dangerous substances noted during this fire risk assessment. It is unlikely given the normal use of the premises that dangerous substances would ever be present on these premises.</p> <p>There is a small cupboard on the lower ground floor that is utilised by the Cleaner, there are small quantities of cleaning products etc that are all controlled by COSHH regs. THIS ROOM IS KEPT LOCKED.</p>	<p>Medium</p>

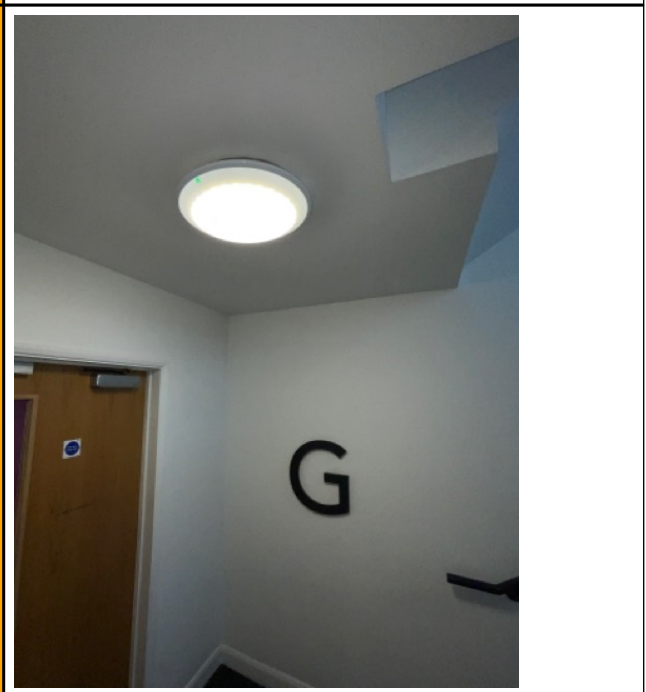
<p>Fire Safety Management</p>	<p>Action/Findings: 13 EMERGENCY ESCAPE LIGHTING</p> <p>Are all escape routes covered by an acceptable form of emergency lighting? YES Has a reasonable standard of emergency escape lighting been provided? YES Does the emergency escape lighting extend to the external areas? NO</p> <p>: Emergency escape lighting is installed throughout the building in all communal routes, cupboards and toilets. The system comprises of what appears to be maintained integrated luminaires with an operating duration of three hours. In addition, bulkheads are provided in certain rooms which are not accessible by the customers or public.</p> <p>All four toilets in the office area on the ground floor are equipped with emergency lighting.</p> <p>Midland Heart does not provide emergency lighting above external exits if there is effective borrowed light. In this instance, there appears to be adequate borrowed light to the front and rear of the premises.</p>	<p>Medium</p>

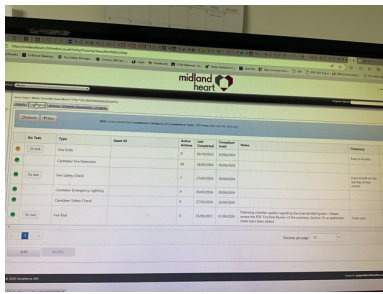
<p>Fire Safety Management</p>	<p>Action/Findings: 19 TRAINING AND DRILLS</p> <p>Is staff training up to date: YES Are Fire Drills carried out and up to date: Yes</p> <p>: All Midland Heart staff who visit and all working members of staff receive an induction and refresher training via an e-learning package, which covers all the essential fire, health, safety and welfare issues. Fire marshals are trained in the use of firefighting equipment in accordance with Midland Heart Health & Safety Policy. The concierge confirmed at the time of this inspection that all concierge staff are trained as Fire Marshalls. Fire Drills are carried out twice yearly with the next drill scheduled for April 2024. The drill involves the office areas only as the rest of the premises is a Stay Put.</p>	<p>Medium</p>
