FIRE RISK ASSESSMENT

Block: Crocodile Court Block Y (*09-*15)
209 ALMA STREET
NEWTOWN
B19 2RL

Date of Assessment: 03/04/2024

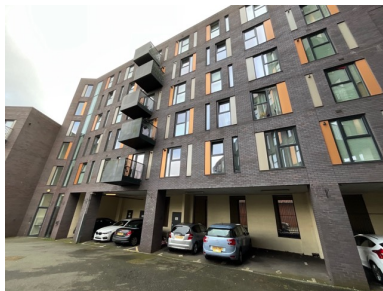
<p>Fire Safety Management</p>	<p>Action/Findings: 2 ELECTRICAL SOURCES OF IGNITION.</p> <p>Are reasonable measures taken to prevent electrical Fires. YES Are fixed installations periodically inspected and tested? YES Is portable appliance testing carried out? YES Is there suitable control over the use of personal electrical appliances? YES Is there suitable limitation of trailing leads and adapters? YES Are there appropriately sited facilities for electrical isolation of any photovoltaic (PV) cells, with appropriate signage, to assist the fire and rescue service? There are no PV cells provided on this block, the adjoins Townhouse, do have solar panels installed on their roof but would not effect this premises.</p> <p>: This risk assessment covers the communal area and offices on the Ground floor, there are no portable appliances in the communal areas, however, the electrical items in the office all are PAT tested every 2 years.</p> <p>The last portable appliance testing was carried out on the 08/08/23.</p> <p>Periodic inspection and testing of the fixed electrical installations EICR are carried out as part of a planned, preventive maintenance programme. The date of the last test was 10/05/22.</p> <p>The use of electrical extension cables are managed well within the office area and appear to be suitable for their required use.</p> <p>All Plugs and sockets appeared to be in good condition and are solely for the use to carry out house maintenance services.</p>	<p>Medium</p>

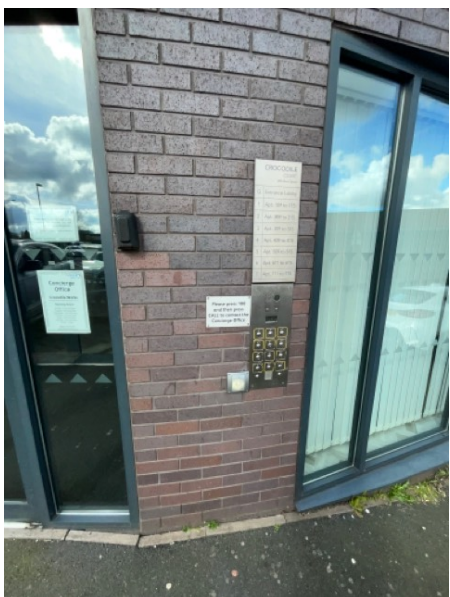
<p>Fire Safety Management</p>	<p>Action/Findings: 4 ARSON</p> <p>Does basic security against arson by outsiders appear reasonable? YES</p> <p>Is there an absence of unnecessary fire load in close proximity to the premises or available for ignition by outsiders? YES</p> <p>: Precautions against arson appear to be reasonable as these Blocks have a Concierge from 07:00hrs until 22:00hrs which monitor and address any anti social behaviour, additionally the Block has:</p> <ul style="list-style-type: none"> # CCTV cameras in operation. # The main entrance doors to the premises are fitted with secure door entry systems. # The main entrance door to the premises was locked at the time of inspection which is monitored by the concierge service. # Refuse bins are located in a secure external bin store. # The building is well lit. # Visiting Staff wear ID badges. # Electricity/Gas meter/cupboard Doors were all locked. # Unnecessary fire loading is well managed and discouraged in 	<p>Medium</p>

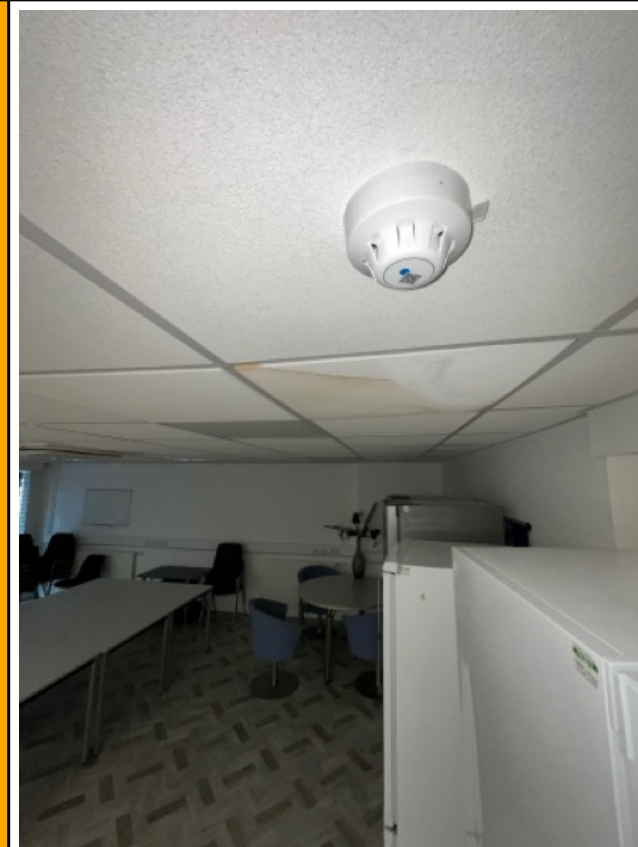
Detection is provided within the front entrance and office area to facilitate a full evacuation with sounders from communal office areas. Manual Call Points are located next to final exits.

The main fire alarm panel is situated adjacent to the reception area in the entrance lobby. The concierge staff test the fire alarm weekly

on a rolling programme. A detailed zone plan is displayed.

The detection appears to be BS5839 part 1, Grade A, L1 coverage in the communal office areas, with a L5 system in the residential communal parts of the building to operate AOV's, lift and door release devices.

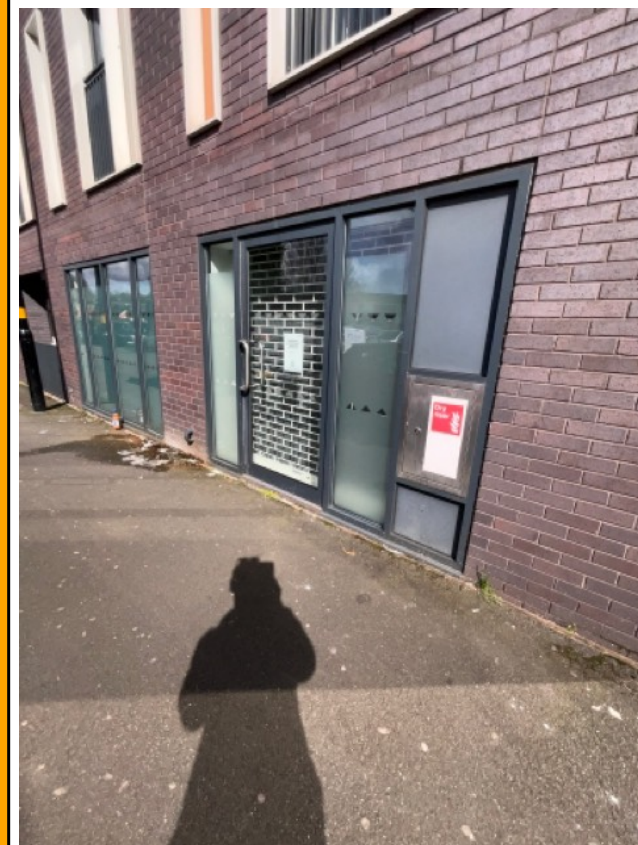
An automatic opening vents are provided within each corridor greater than 4.5m and also at the head of the protected staircase. The building design incorporates a single flat within the lift lobby area of all floors, this section does not have AOV protection. This is

a deviation from guidance but with only a small area, circa 4m, to pass through for escaping residents, it does not pose a significant risk. In mitigation there are nominal, good quality, FD30s Fire doors on all flat front doors, the lift lobby is only circa 4m in length, there is a Stay Put policy in place and the neighbouring corridor and stair both have this facility. The design would be compliant, were it not for the cross corridor door separating this corridor and it is felt that this cross-corridor door is more beneficial in keeping the travel distances short outweighs this absence. Therefore this design is not considered to place anyone at significant risk.

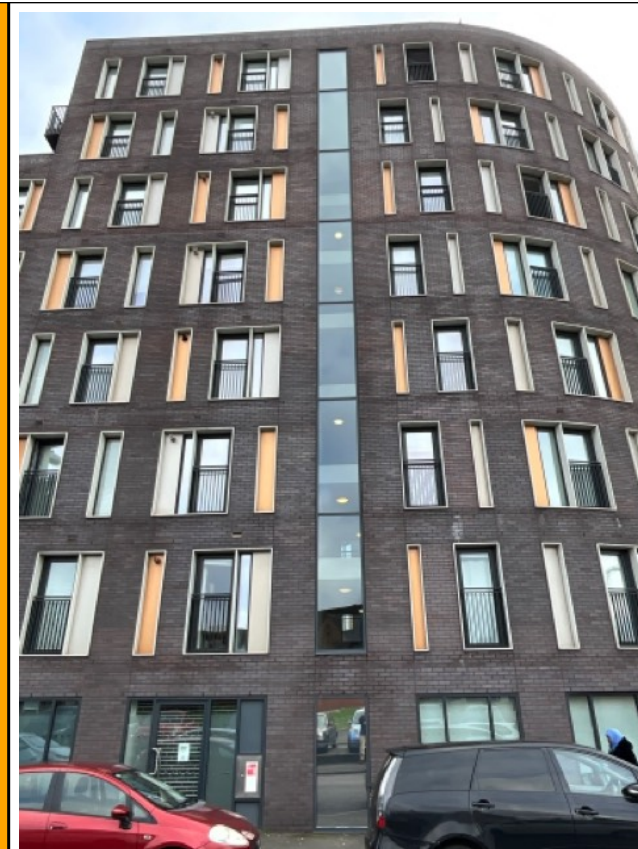
It was not possible to examine all flat entrance doors. However, a selection of doors were examined. The doors were found to

conform with the current FD30S standard, some with British Wood Federation certification labels attached. The fire doors inspected are provided with an overhead self-closer, intumescent strips and seals, three CE marked hinges, adequate rebates and each door has a thumb twist device internally. The remaining flat entrance doors are believed to conform to the same standard as they are similar in condition and appearance.
