Building Safety Case Report

Crocodile Court (Block Y)

Address: 209 Alma Road, Birmingham, B19 2AG

Version: 2.0

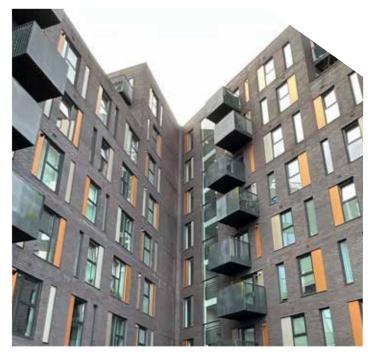
Decorative Features: Less than 10% of the exterior is decorated with isolated Aluminium Composite Material (ACM) panels, which are strategically placed and do not perceive to facilitate vertical or horizontal fire spread in the event of fire.

Figure 1 - View of decorative ACM on external walls and balconies

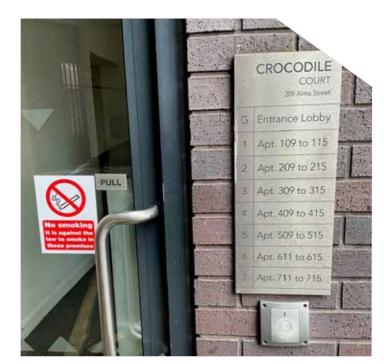
Figure 2 - Flat numbering index

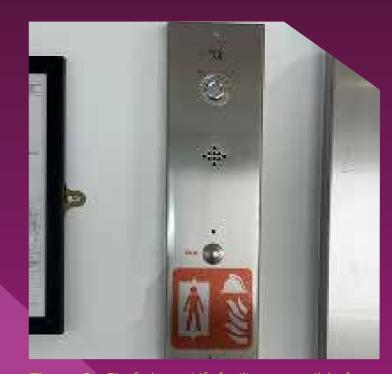
A key feature within the building is the 'firefighting lift', equipped with innovative 'Peek-a-Boo' functionality. This allows firefighters to check for safety before exiting the lift during emergencies. The lift system also includes an intercom on each floor for essential communication and an escape hatch for emergency egress. Regular safety checks are conducted monthly by certified contractors and weekly by concierge staff, with any urgent life Critical defects reported directly to the West Midlands Fire Services via their defect portal if unable to rectify within 24hrs.

Figure 3 - Firefighters Lift facility accessible from the main entrance.

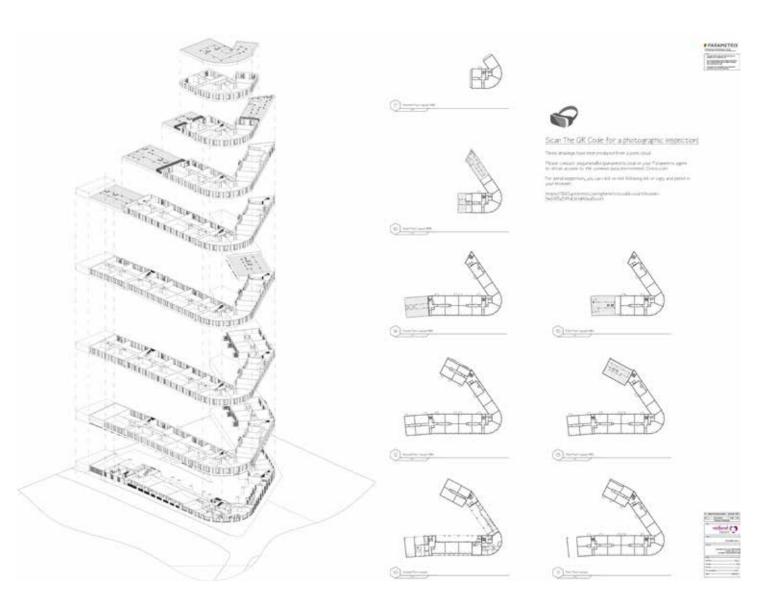
Each apartment, along with the building's lobbies and central protected stairwell, is designed as a distinct fire compartment, engineered to inhibit the spread of fire for a minimum duration of 60 minutes. This fire resistance capability is achieved using materials specifically chosen for their fire-retardant properties. In instances where any breaches of these fire-resistant barriers have been identified, remedial actions have been promptly undertaken. These repairs are carried out exclusively by third-party accredited fire-

Figure 5 - 3D drawing of Crocodile Court Block Y which indicates the escape routes which are protected by 60 minutes fire resisting construction (Source: Crocodile Court Block Y building plans.

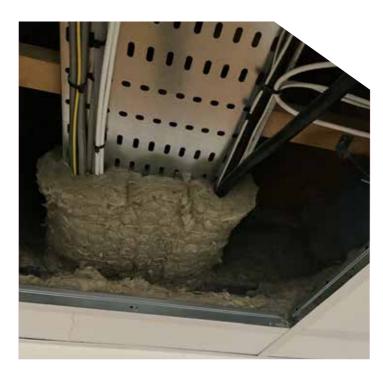
stopping contractors. The materials and methods used for these repairs adhere to the appropriate standards of fire safety, utilising fire-resisting products that have been tested and certified to meet or exceed required safety specifications. This proactive approach ensures the integrity of fire containment strategies throughout the building, maintaining a safer living environment for all residents.

Figure 6 - Picture of compartmentation technique in communal spaces for cable penetrations.

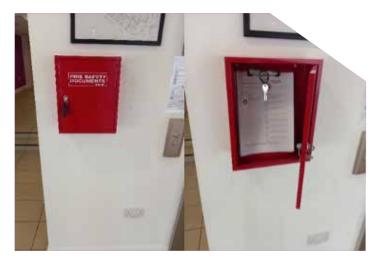
In line with the Fire Safety (England) Regulations 2022 there is a premises information box (PIB) with information to support the fire service in the event of an incident. This contains.

- Building Plans with Key system location and isolation points
- Emergency Response Plans
- Emergency Evacuation Information Sharing
- Service Keys.

Figure 8 - Premises Information Box installed at Crocodile Court Y Block
